Atherstone EM to WM Transfer

Measurement Error WM014

NGGD Ref no. MER/UKD/182/13

Over-registration of 12 Mscm

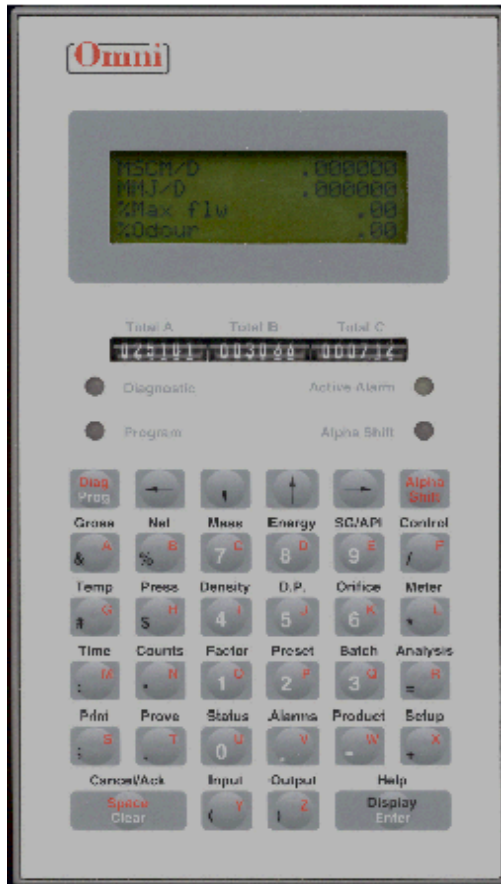
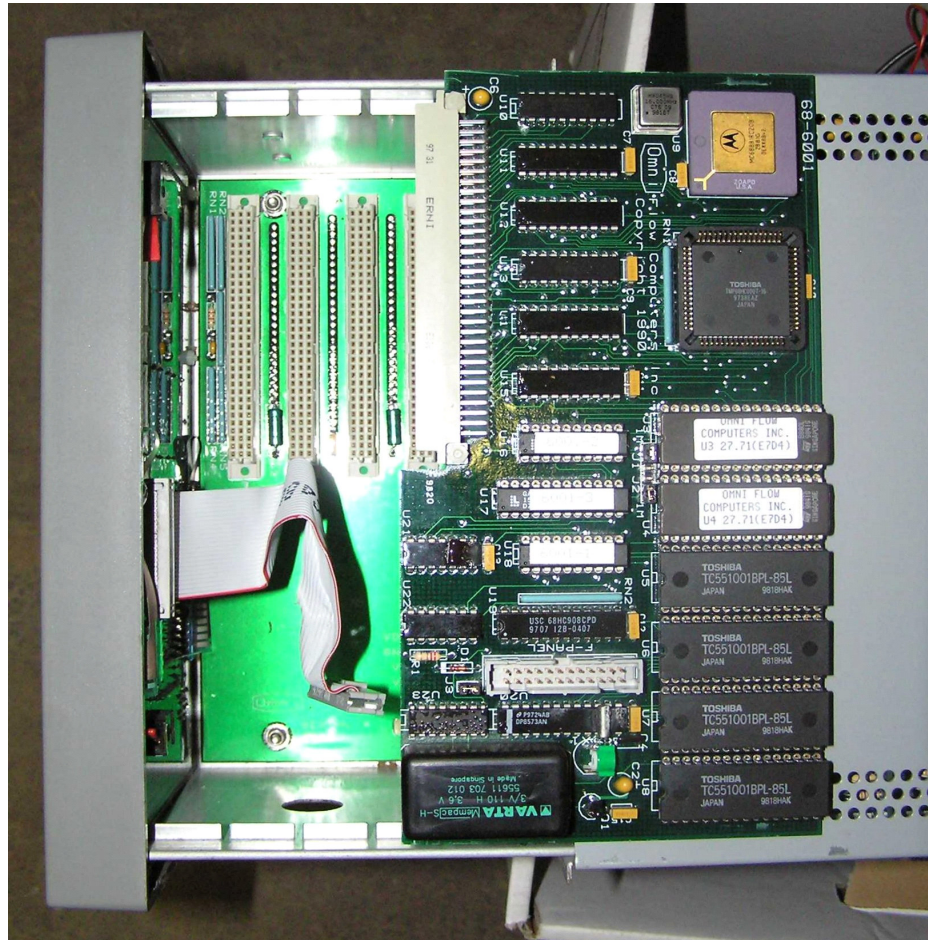
Omni 6000 Flow Computer CPU (EPROM-type)
Back-up Battery and EPROM Location
plus OmniCom Start-up Screen

Following the swapping of an Omni flow computer CPU to deal with on board battery backup failure, a different version of EPROM firmware was inadvertently deployed. Whilst this was still applicable to a gas application, the version in question was not fully compatible with the OmniCom version that was resident on the supervisory system.

No obvious incompatibility was noted at the time, but from retrospective study, it is believed that at least one Modbus data location had changed/been introduced between the respective firmware versions. Following a later attempted full T/PR/ME/2 validation, it was noted that the density calculation was not being undertaken appropriately. Further investigation revealed that the compression factor Z was being reported in excess of 1. The root cause was traced to an inappropriately set Base Pressure figure in the Fluid Product setup area in the firmware that was installed. Such a configuration option is not available in the present NGGD normally deployed versions of firmware.

In the event that an exchange CPU is intended to be deployed to undertake this work, and it is not populated with the correct version of firmware, it is permissible, with care, to remove the EPROMs from the outgoing CPU and install them into the incoming CPU.
