GL Noble Denton

Aberdeen SMER SC006

20th August 2013

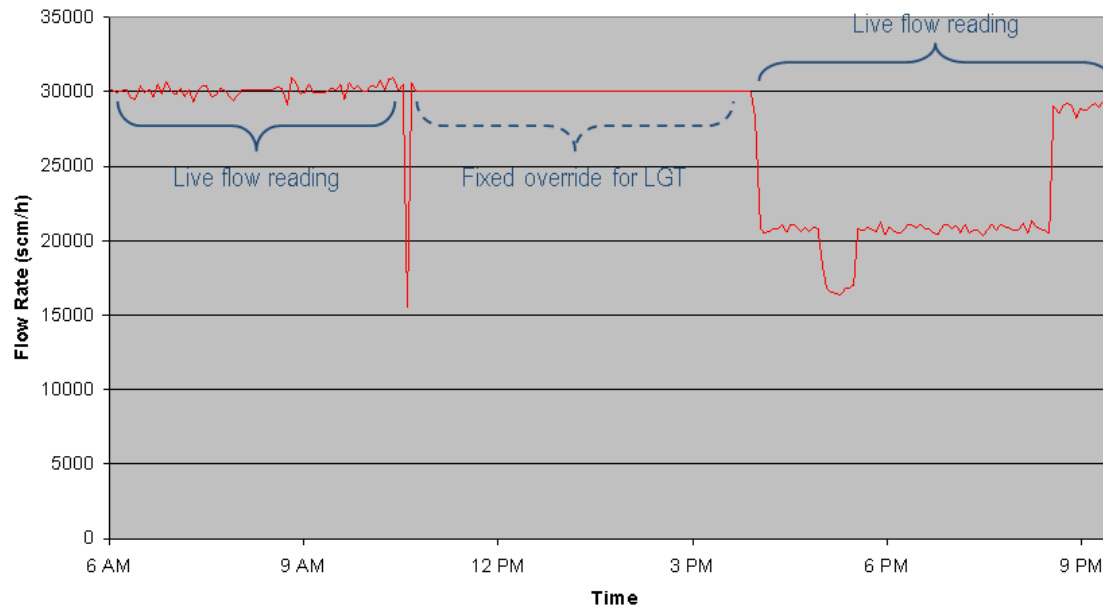
Flow Profile 21st July 2009

- 21st July 2009 – Problem was introduced at orifice plate change
 - ~30 kscm/h site flow prior to plate change
 - ~21 kscm/h site flow following plate change
 - Indicates an under-registration of 31 % following change

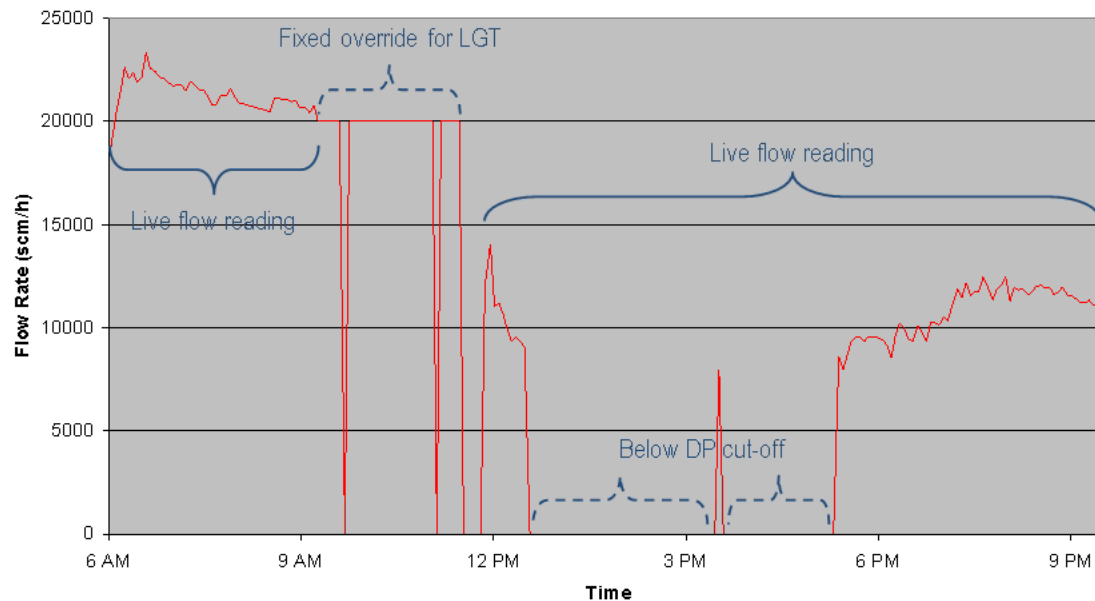
Flow Profile 27th July 2010

- 27th July 2010 – Orifice plate was changed
 - Transient flow rate before and after plate change
 - No direct comparison available
 - DP was close to the low cut-off and some zero flow rates were recorded

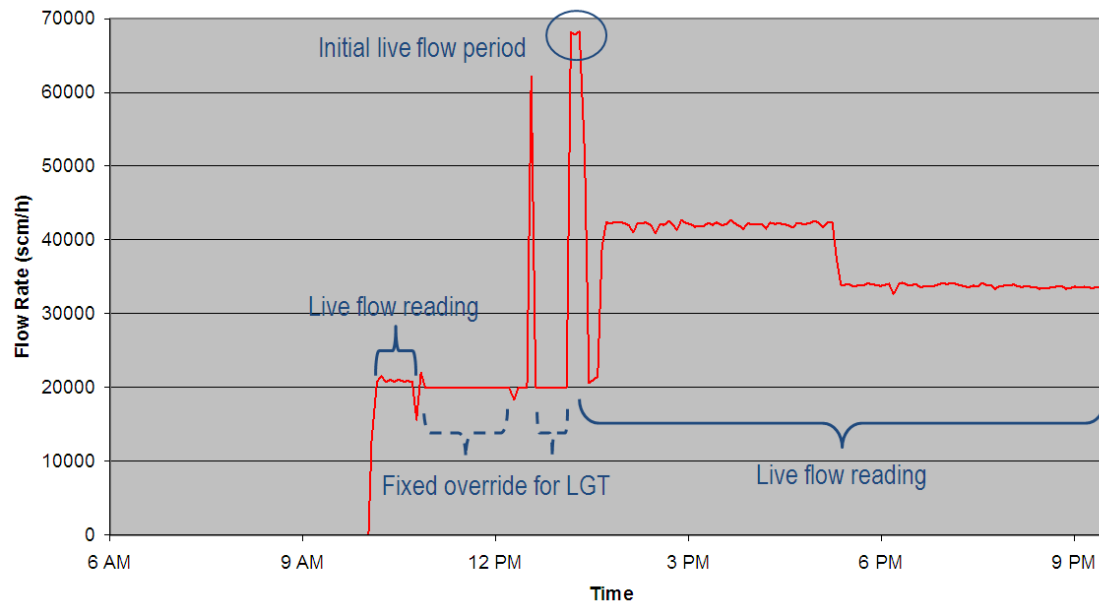
Flow Profile 10th August 2010

- 10th August 2010 – Fault corrected
 - ~21 kscm/h site flow prior to correction
 - ~68 kscm/h site flow following correction
 - Indicates an under-registration of 69 % before correction

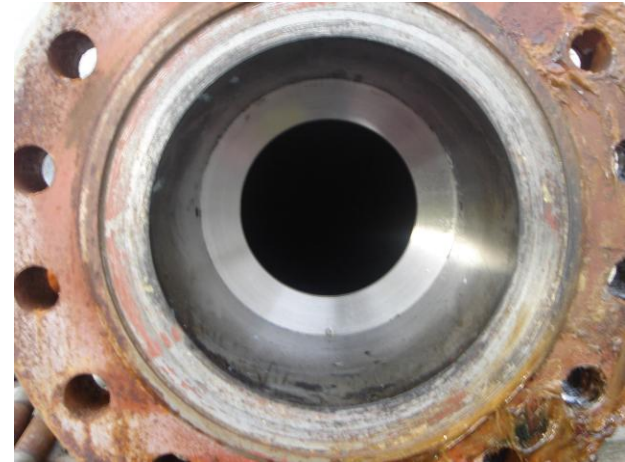
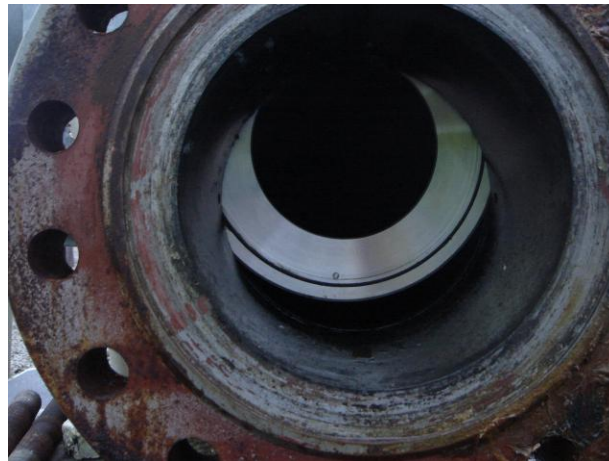
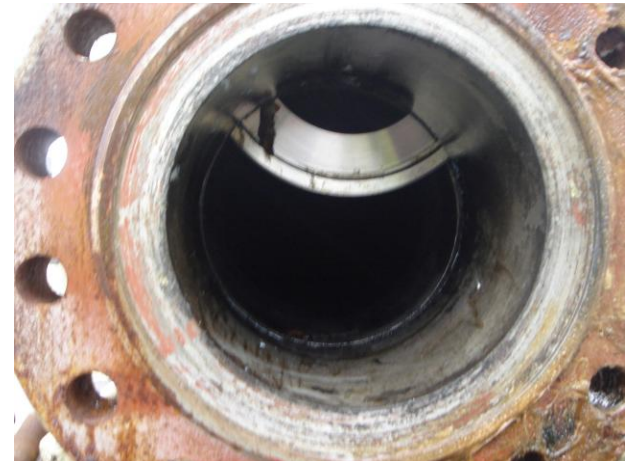
- 00000 Correct location (top right)
- 99950 Correct location (bottom right)
 - Offset of 173.0 mm
- 99984 Correct location (bottom left)
 - Offset of 51.3 mm

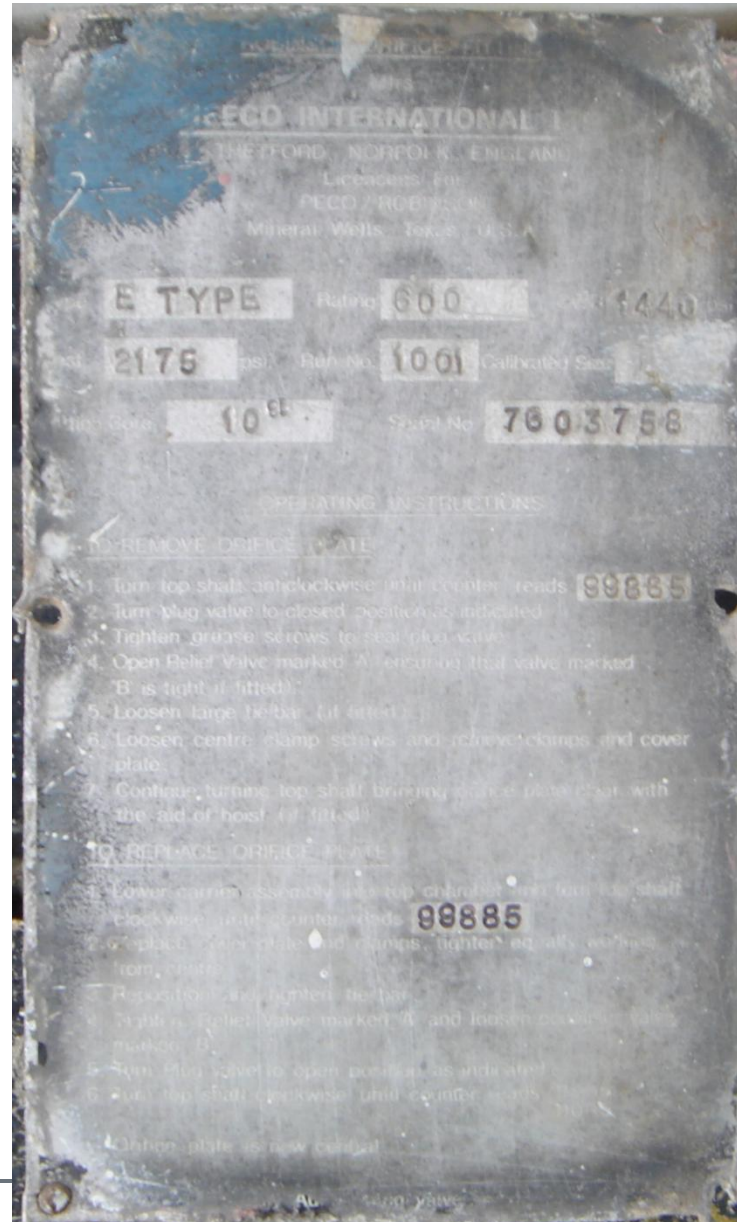
- Identification plate
 - Serial number and carrier specification
- Information plate
 - Step by step Instructions on removal and insertion of orifice plate
 - Not easily readable

- The information plate states that the fully inserted position should be at a counter reading of between 9995 and 0005
 - Five digit counter
 - Fully inserted position is exactly 00000
- From this it can be seen that the four digit 9995 counter reading was likely to have been misinterpreted as a five digit reading of 99950
- No evidence to support a counter reading of 99984 (estimated from initial analysis)
- However it was thought that the 99885 which is stamped in two locations on the carrier information plate could have been misread as 99985

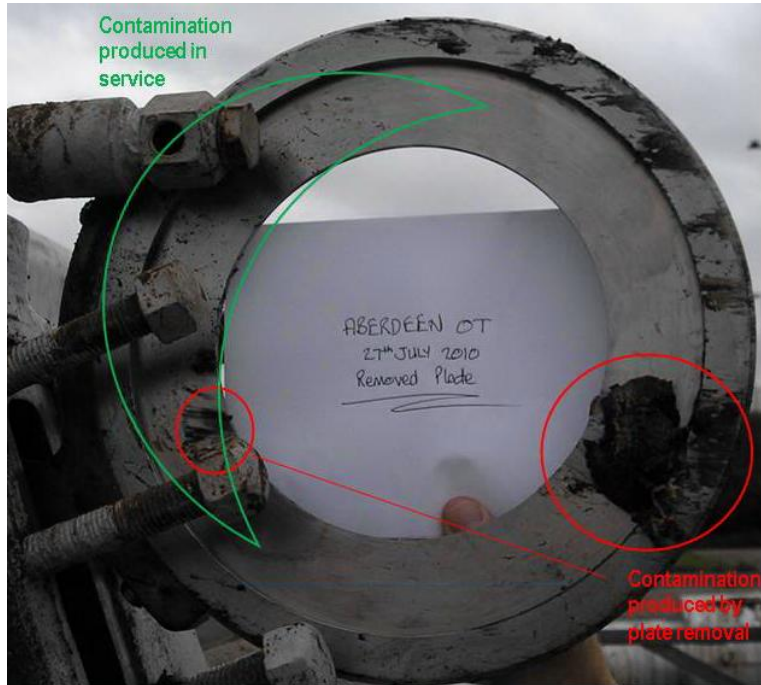
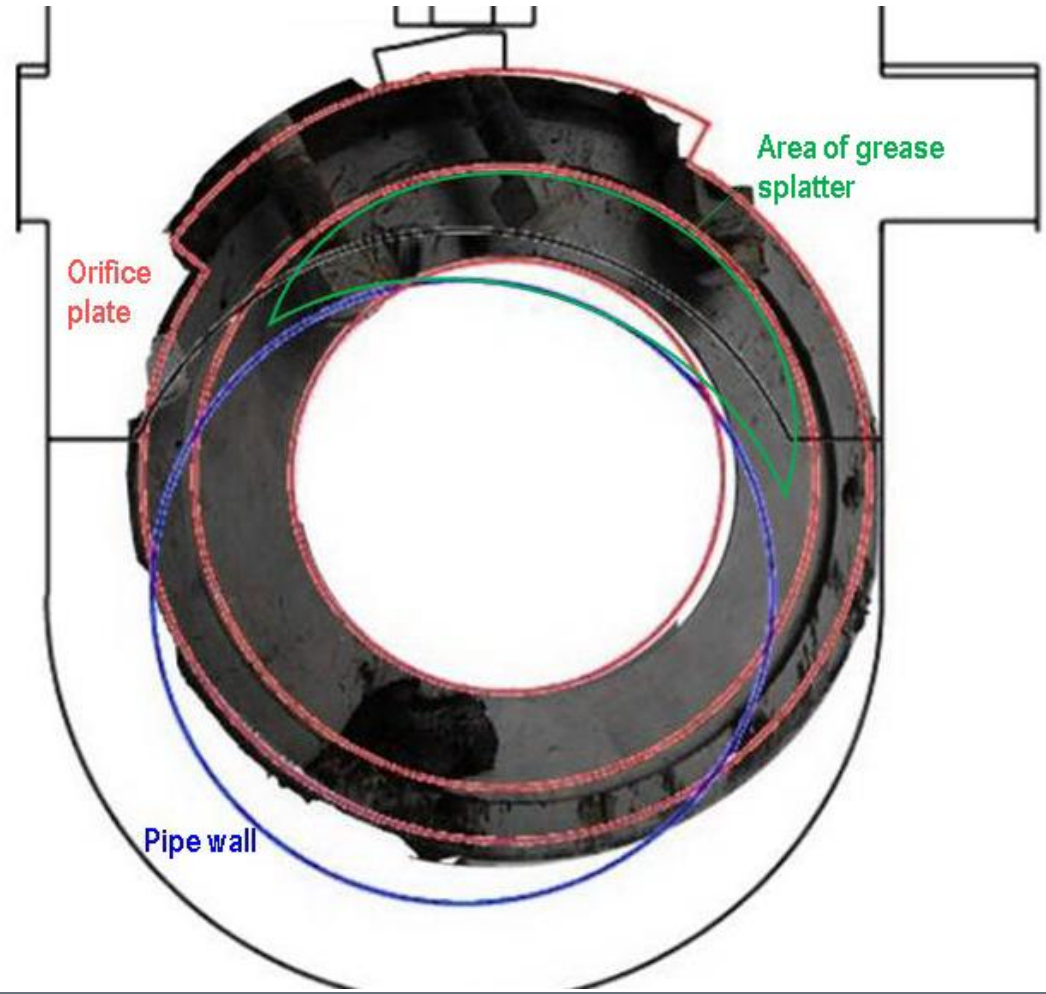
- July 2010, Upstream

- Photographic records are kept of each plate (both faces) on insertion and removal
- Plate removed on 21st July 2009 was clean
- Plate removed on 27th July 2010 showed some contamination
 - Location supports 99985 counter reading
- Plate removed on 29th July 2011 showed some contamination
 - Pattern consistent with normal flow conditions
 - No significant effect based on quantity and location

- The splatter pattern suggests small amounts of grease being picked up and deposited by a flow of gas
- Contamination of this kind would be removed by the flow of gas under normal operating conditions (higher flow rates), particularly around the bore edge
- This is an indication that normal gas flows were not experienced by this part of the orifice plate

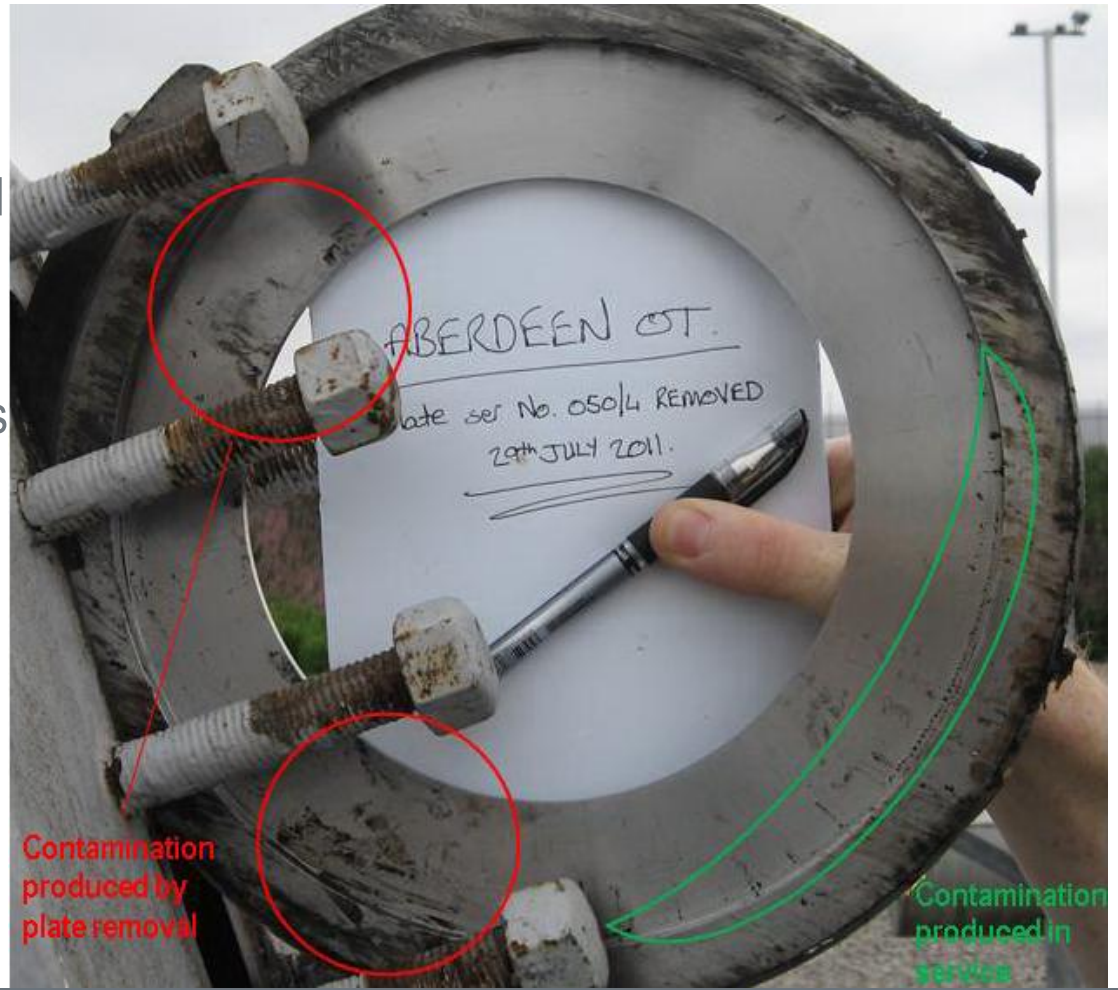
- July 2011, Upstream
- Typical of minor contamination experienced in service
- Confined to outer annulus
- Streaking radially outwards
