CALCULATION OF PE LEAKAGE

PE distribution main leakage estimation for Independent Gas Transporters

Independent Networks Association

Report No.: 10175924-1, Rev. 2

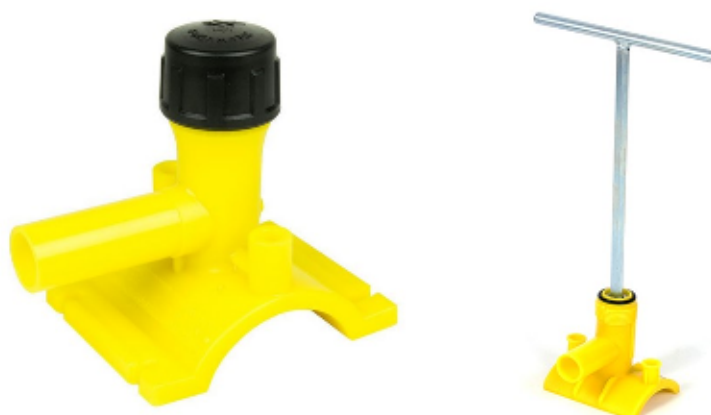
Figure 4: Electrofusion saddle tee with black completion cap (left); cap removed to operate the integral cutter, exposing elastomer seal (right)

These are fitted with an elastomer seal around the top of the cutter (located under the "completion cap"). These fittings have led to failures of tightness tests where they have been incorrectly assembled

(i.e. the cutter not returned to its fully home position, and/or the completion cap not fully tightened). Examples are shown in Figure 4.

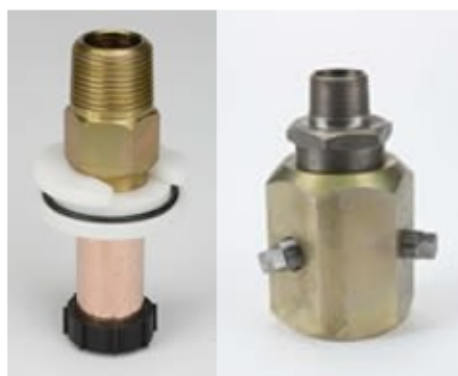
Figure 5: Meter Box Adapter (left) and Service Head Adaptor (Right)

Incomplete crimping of the PE pipe to the adaptor may result in slight leakage, again this should be observable via tightness testing. See Figure 5 for adapter examples.

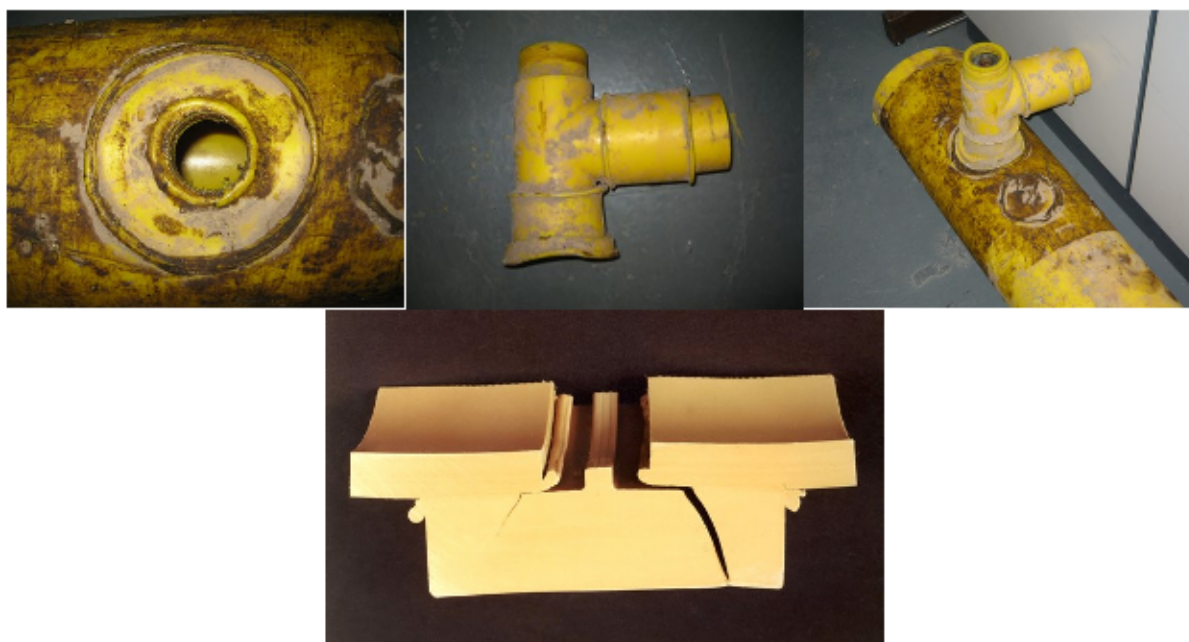
Figure 6: Examples of hot iron joint failures: saddle (upper), pipe joint (lower)

Hot iron and socket fusion joints were prone to failure due to the reliance on operators to ensure the correct pressure, temperature and alignment. Examples of hot iron joint failures are shown below in Figure 6. Such failures are most likely to have occurred at the time of installation and will therefore not be relevant to the IGTs.

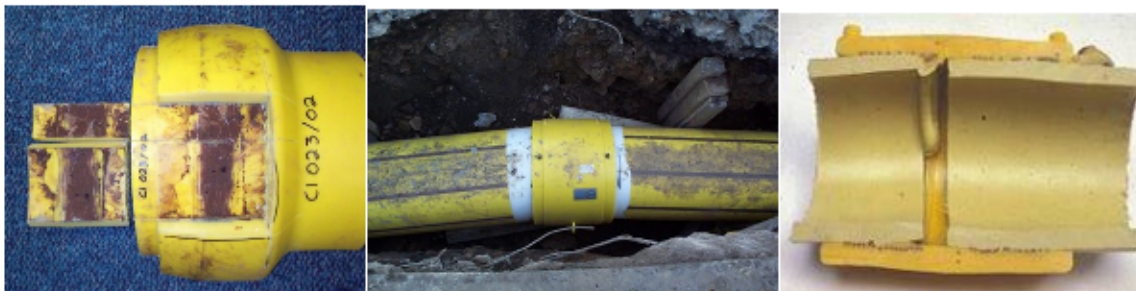
Figure 8: Examples of electrofusion coupler joint failure: gross contamination (left), gross misalignment (centre), and section through misaligned joint showing constrained leakage path (right)

Failure of electrofusion coupler joints occurs for the same reasons as butt fusion joints (contamination, cold lap joints, misalignment). Examples are shown in Figure 8. The extent of a breach would again depend on the area of contamination, or the poorly heated zone, and the degree of misalignment would also have an effect. It may be the case that smaller diameter pipes can be bent more easily into the required alignment, which suggests a diameter influence on likelihood. The magnitude of release would again depend on the extent of the defect (i.e. it would not be diameter dependent), but would be smaller than a full-bore release as the leak path is the relatively narrow gap along the failed interface between the pipe and coupler, which may be of the order of 1-2mm wide. Again, such failures are likely to have been apparent at the time of installation and to be remediated during commissioning. The use of "remote" supervision ("ControlPoint" being the most well-known example) further improves the quality of modern PE joints and is used by many of the companies undertaking PE main laying.

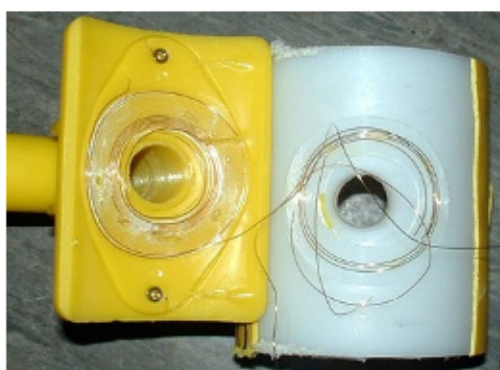
Figure 9: Electrofusion saddle joint failure causing complete separation of top tee from pipe

Where the failure is in a fitting (i.e. a saddle/top tee), then leakage would occur where the fitting has separated from the pipe (either partially or fully), shown in Figure 9. The amount of leakage would depend how much of the joint surface had parted, and maximum leakage would occur if the fitting is totally detached from the pipe, and the rate would be governed by the drilled hole (which is typically 20-30mm). The leakage from this breach would be independent of the PE main diameter.
