Atherstone EM to WM Transfer

Measurement Error WM014

NGGD Ref no. MER/UKD/182/13

Over-registration of 12 Mscm

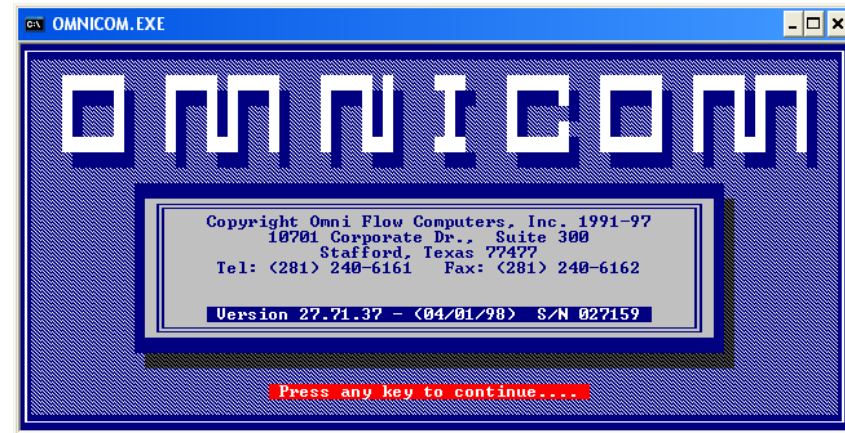
Omni 6000 Flow Computer CPU (EPROM-type)
Back-up Battery and EPROM Location
plus OmniCom Start-up Screen

OmniCom, installed on the supervisory system did not display this erroneous Base Pressure value in the Fluid Product setup area and all impressions given lead the operative to conclude that all was well with the resulting installation.

As a result, the reference conditions for the AGA8 calculation were inappropriately set which resulted in incorrect density and compression factor Z derivation. This in turn impacted upon the reported flow rate.

In addition to applying standard pre and post checks, it is also recommended that additional attention is paid to the calculated compression factor Z and density. Any suspect values are required to be investigated before declaring the work complete.
