GL Noble Denton

Aberdeen SMER SC006

20th August 2013

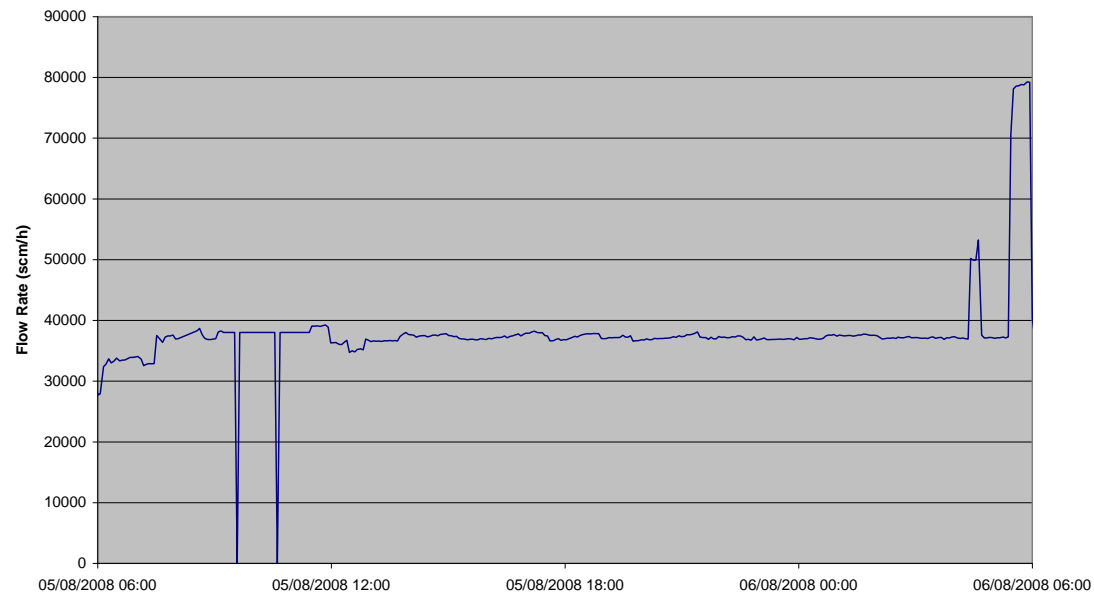
Flow Profile 5th August 2008

- 5th August 2008 – Correct orifice plate change
 - ~38 kscm/h site flow prior to plate change
 - Fixed flow (38 kscm/h) recorded for duration of plate change
 - ~38 kscm/h site flow following plate change

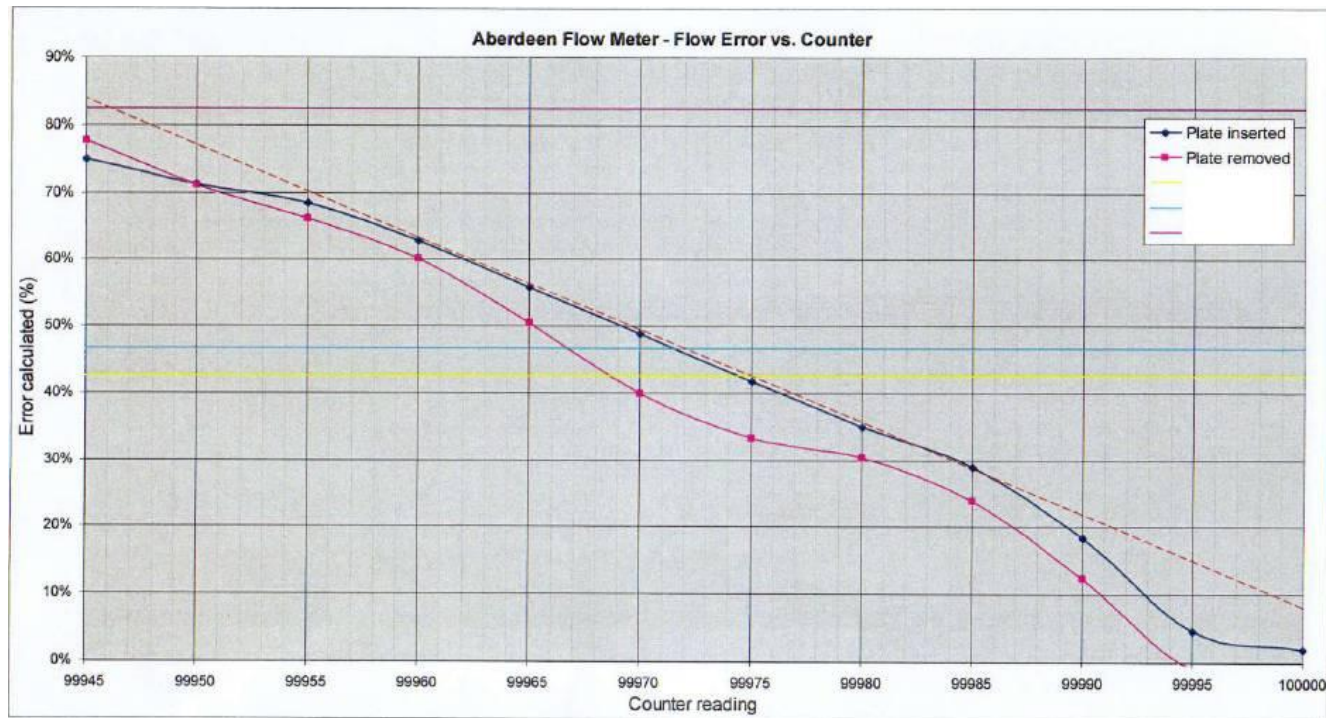
- Initial tests were carried out by downstream party to estimate error magnitude
 - Prior to appointment of ITE
 - Not suitable as quantification of error

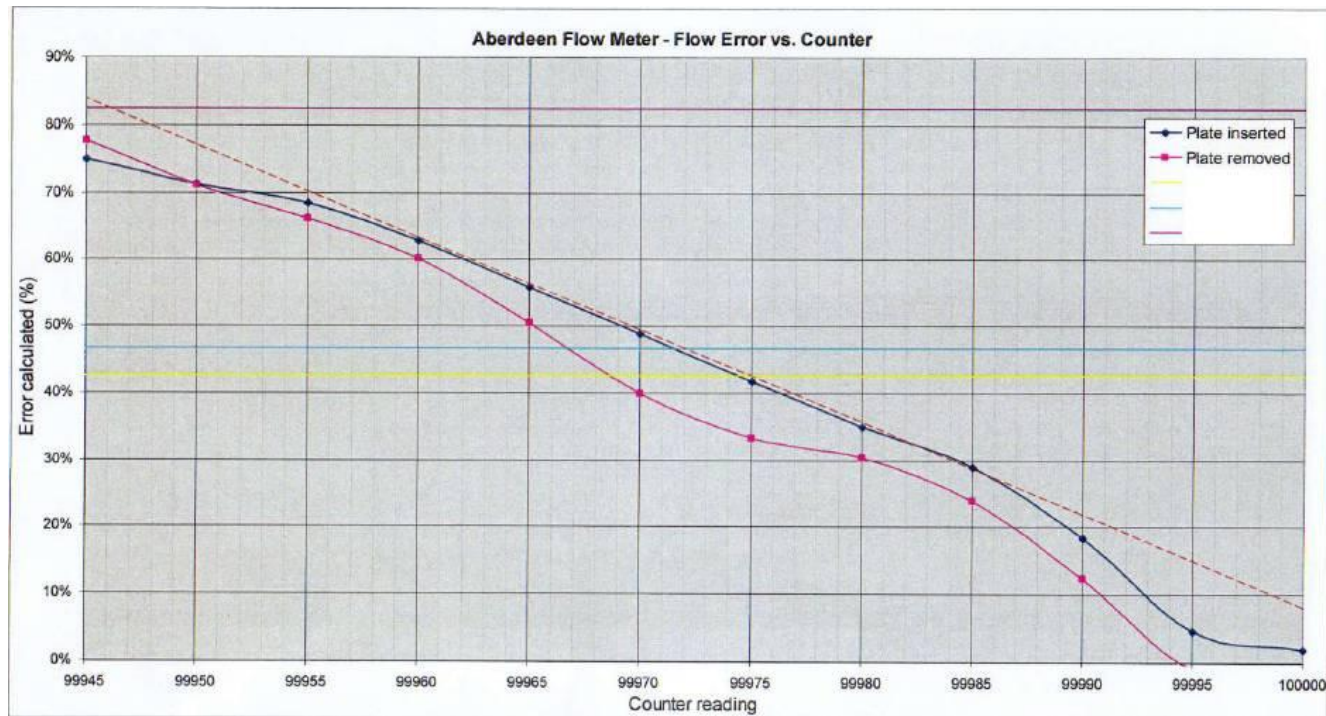
- Error at 99950 counter reading shown as 71%
 - Compares well with 69% estimated from step change
- Step change of 31% suggests that the unknown counter reading is ~99984

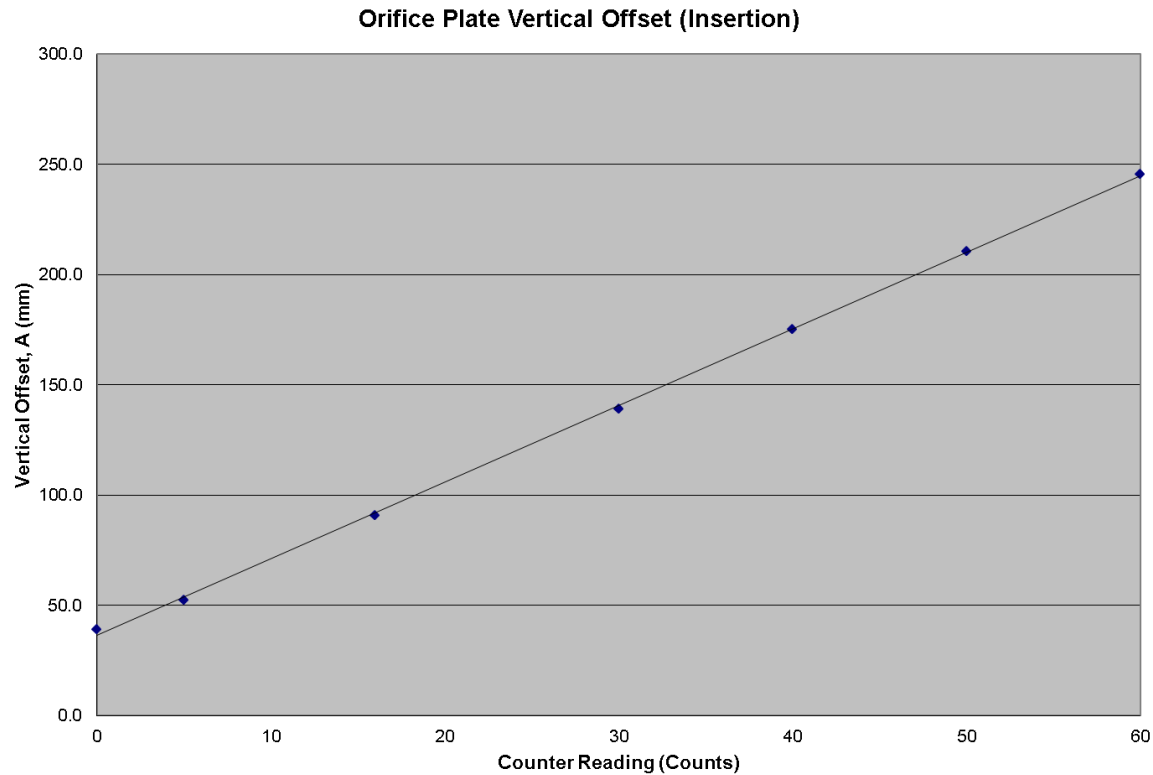
- Linear profile

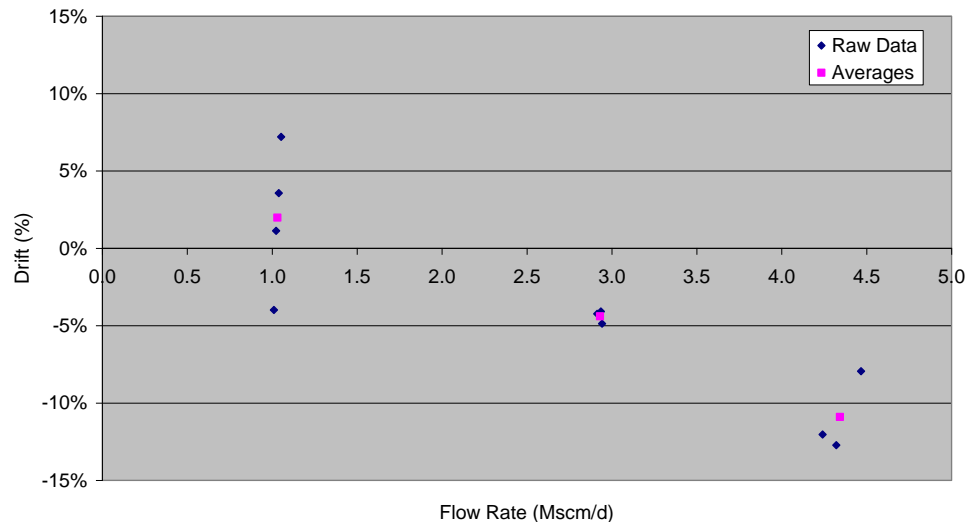
Graph of Drift against Flow Rate

- Flow rate drift was caused by mis-match between the supplied flow rate and the downstream demand (~2 Mscm/d)
- This was most prevalent at the highest flow rates (i.e. where the difference between supply and demand was at it's the greatest)
- Assumed to be linear over the duration of each test

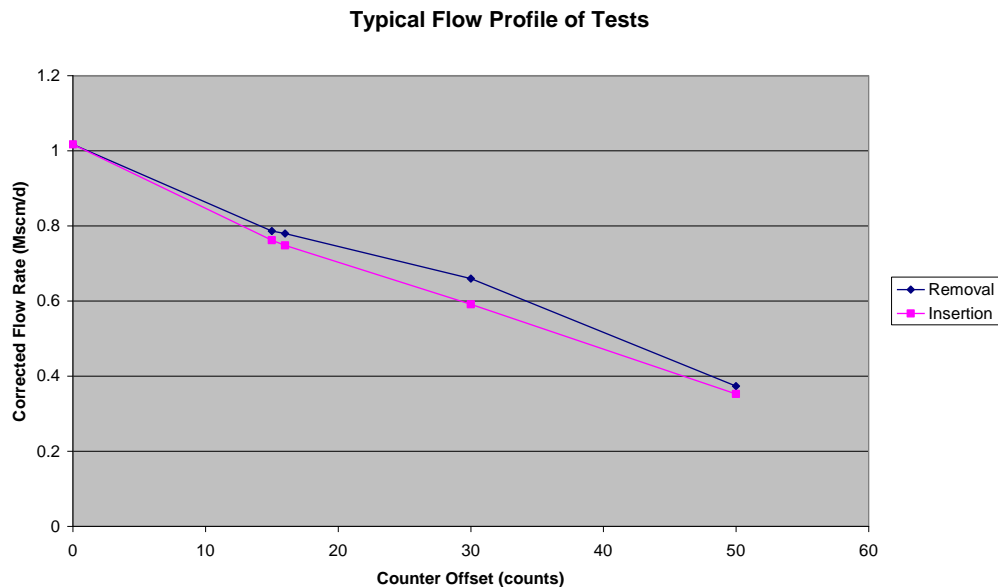
- At each point there was a slight difference in results between removal and insertion due to the difference in direction of the horizontal offset
 - Plate moves towards the differential pressure tapping points on removal and away from them on insertion
- Results in slightly higher flow rates on removal

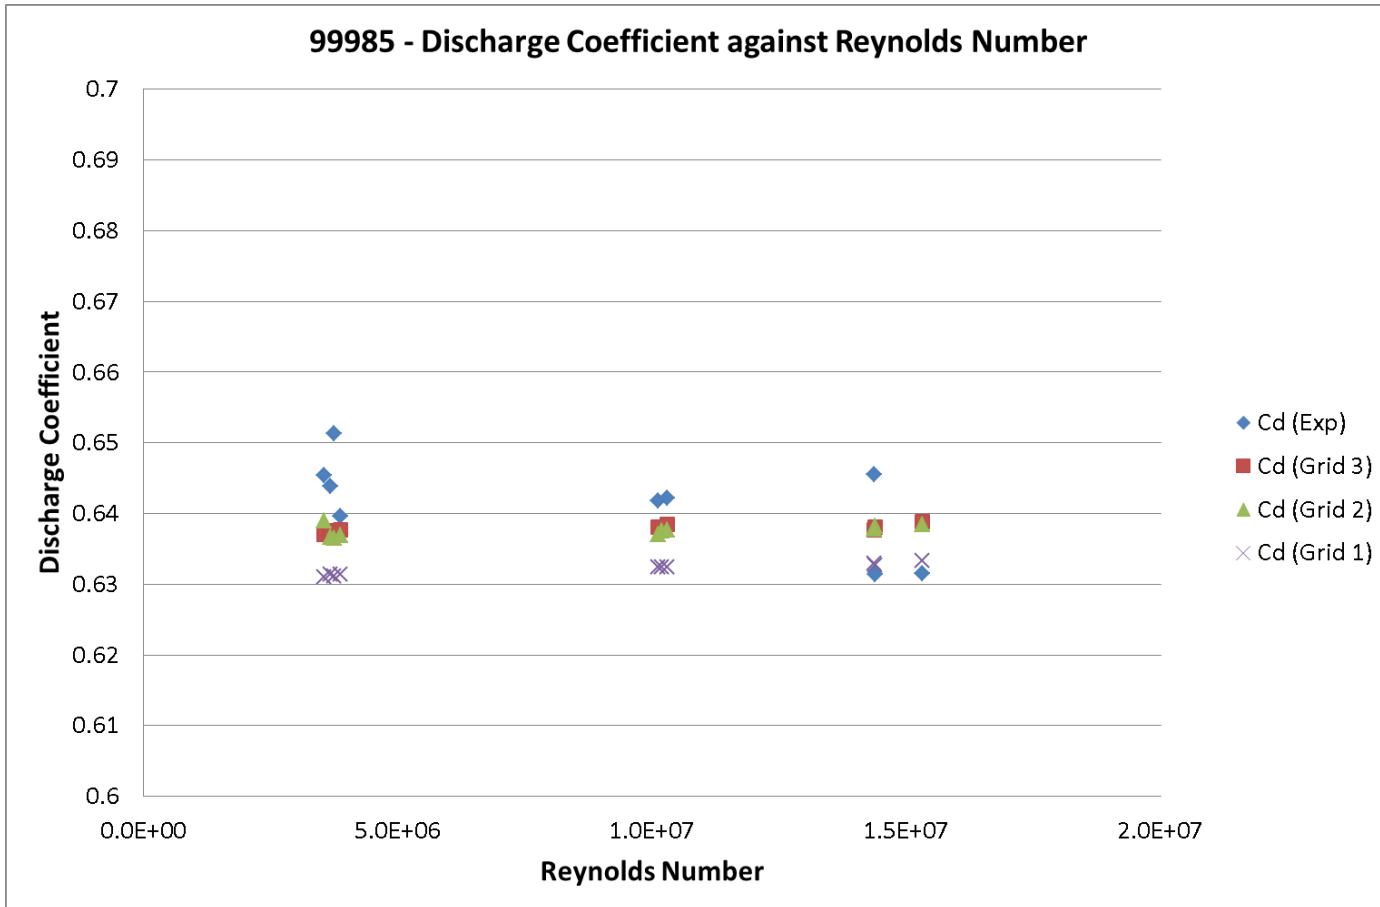
Results - CFD - 99985

- Comparison of CFD and experimental results
 - DP measurement uncertainty used as acceptable tolerance
 - Grid independence considered acceptable under 1%
- 99985 counter reading
 - 7/10 within DP measurement uncertainty
 - Other three were up to 2.5% (vs. 1%)
 - All grid independent (< 0.5%)
- 99950 counter reading
 - 6/10 within DP measurement uncertainty
 - Two others on limit of tolerance (42% vs. 40% and 2.6% vs. 2.5%)
 - Other two were 10% and 4.2% (vs. 6% and 2.5%)
 - All grid independent (< 0.7%)
- All results show error to be independent of process conditions

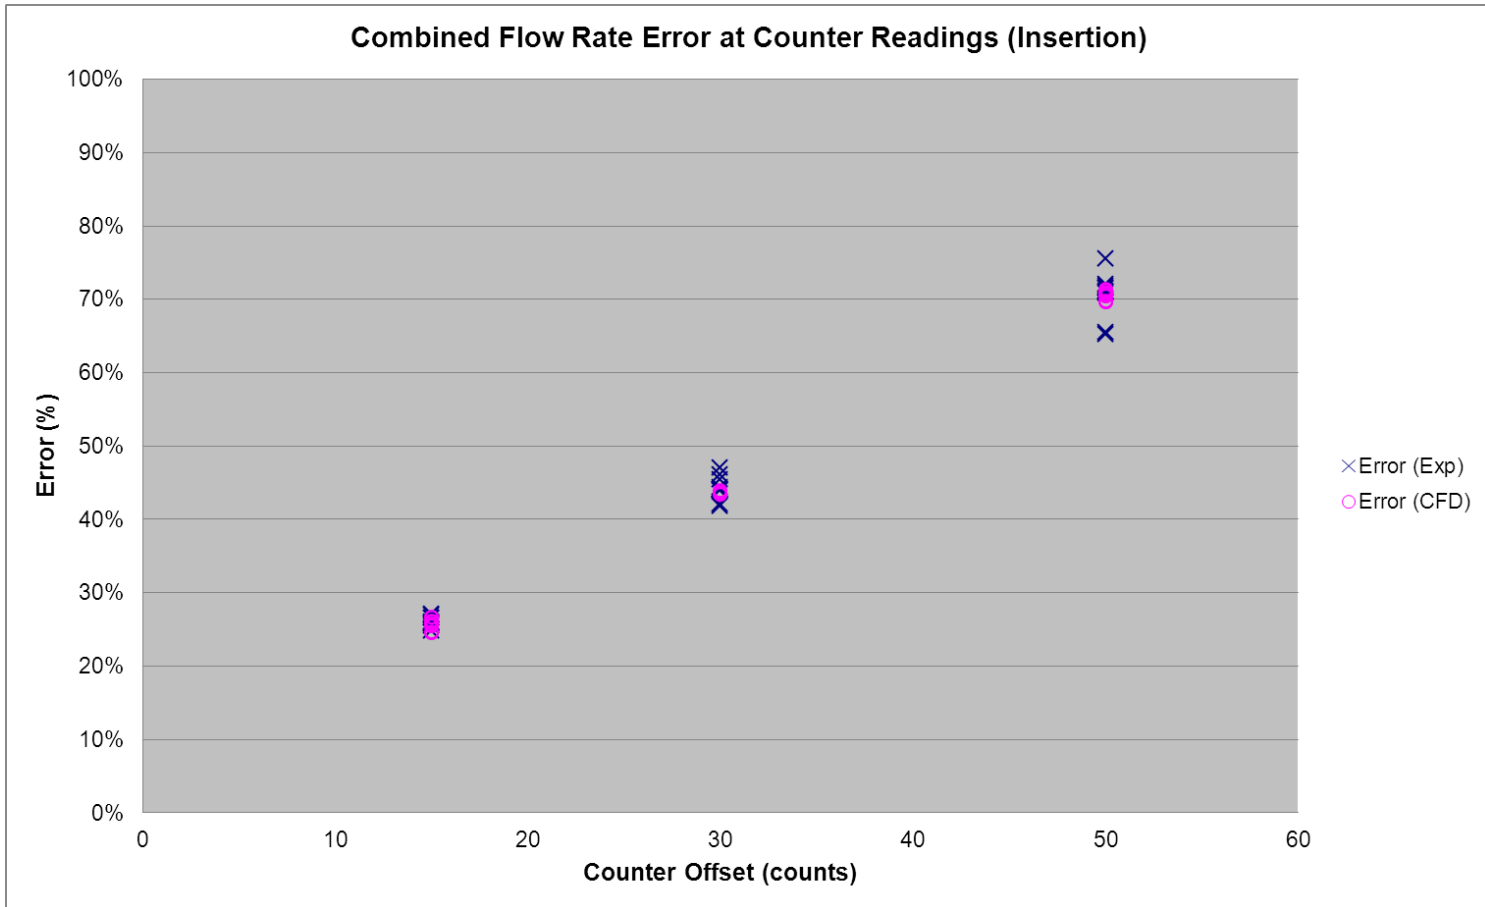
Results - Combined

Counter Reading	Experimental Error (%)		CFD Error (%)		Difference in Mean (% relative)
	Mean	Std. Dev.	Mean	Std. Dev.	
99985	26.1 %	0.7 %	25.7 %	0.7 %	-1.4 %
99950	70.6 %	3.1 %	70.6 %	0.6 %	0.0 %

- High standard deviations at low DPs
 - Expected with higher uncertainty of DP measurement

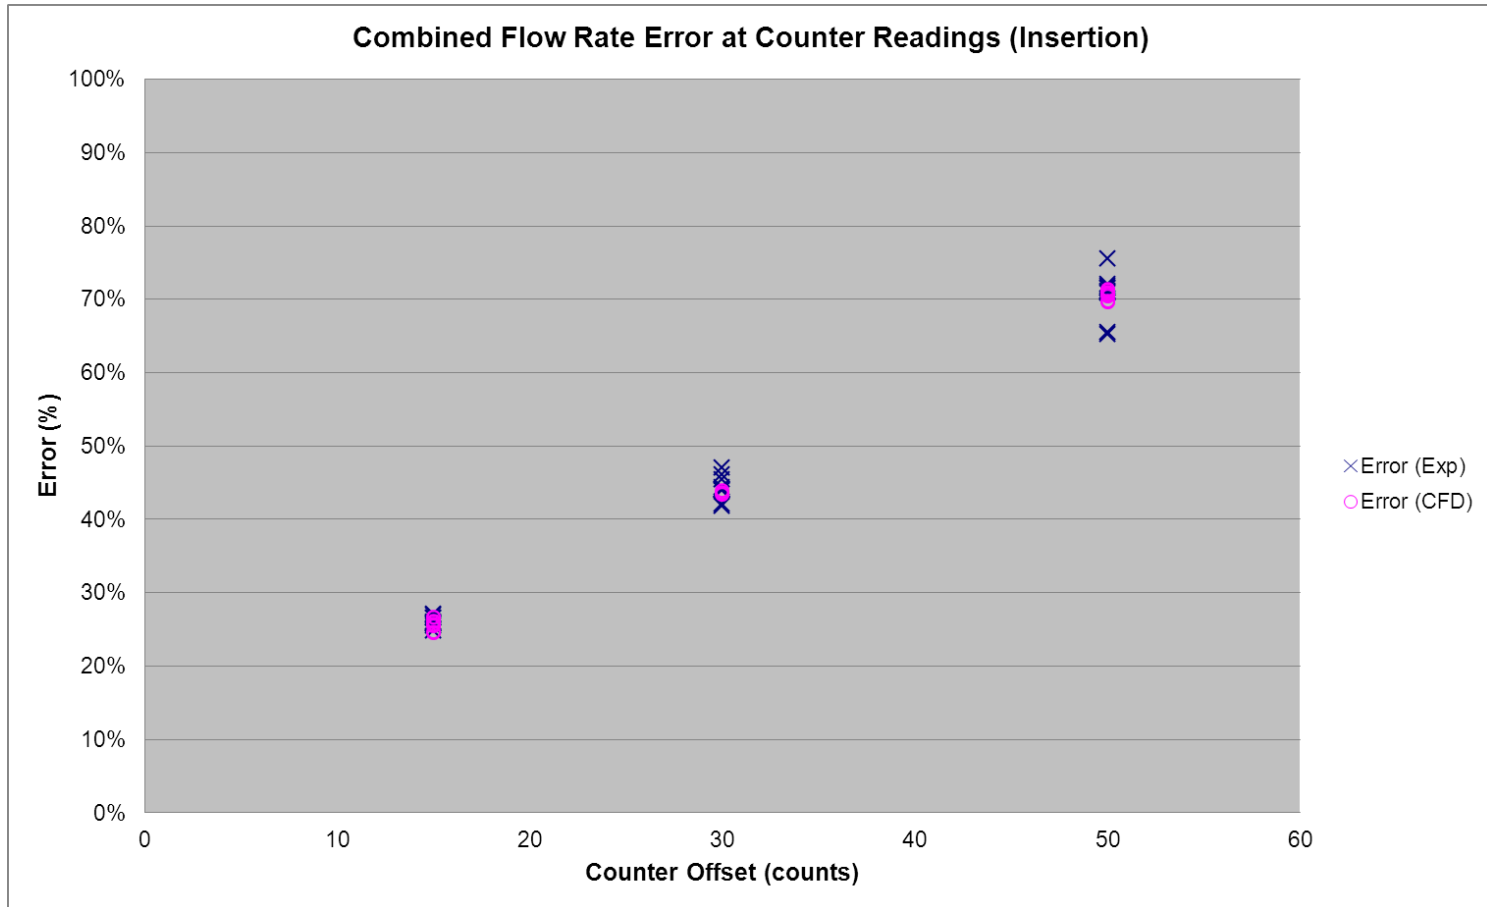
Results - Combined

Counter Reading	Experimental Error (%)		CFD Error (%)		Difference in Mean (% relative)
	Mean	Std. Dev.	Mean	Std. Dev.	
99950 (All)	70.6 %	3.1 %	70.6 %	0.6 %	0.0 %
99950 (>10 mbar)	71.5 %	0.4 %	71.0 %	0.3 %	-0.7 %

- Excluding DPs below 10 mbar significantly reduces standard deviation
 - Demonstrates that the two data sets are more reliable above 10 mbar
